BUREAU OF SHIPS GROUP TECHNICAL INSPECTION REPORT

U.S.S. SEARAVEN (SS196)

TEST ABLE [U]. 8

6 OPERATION CROSSROADS

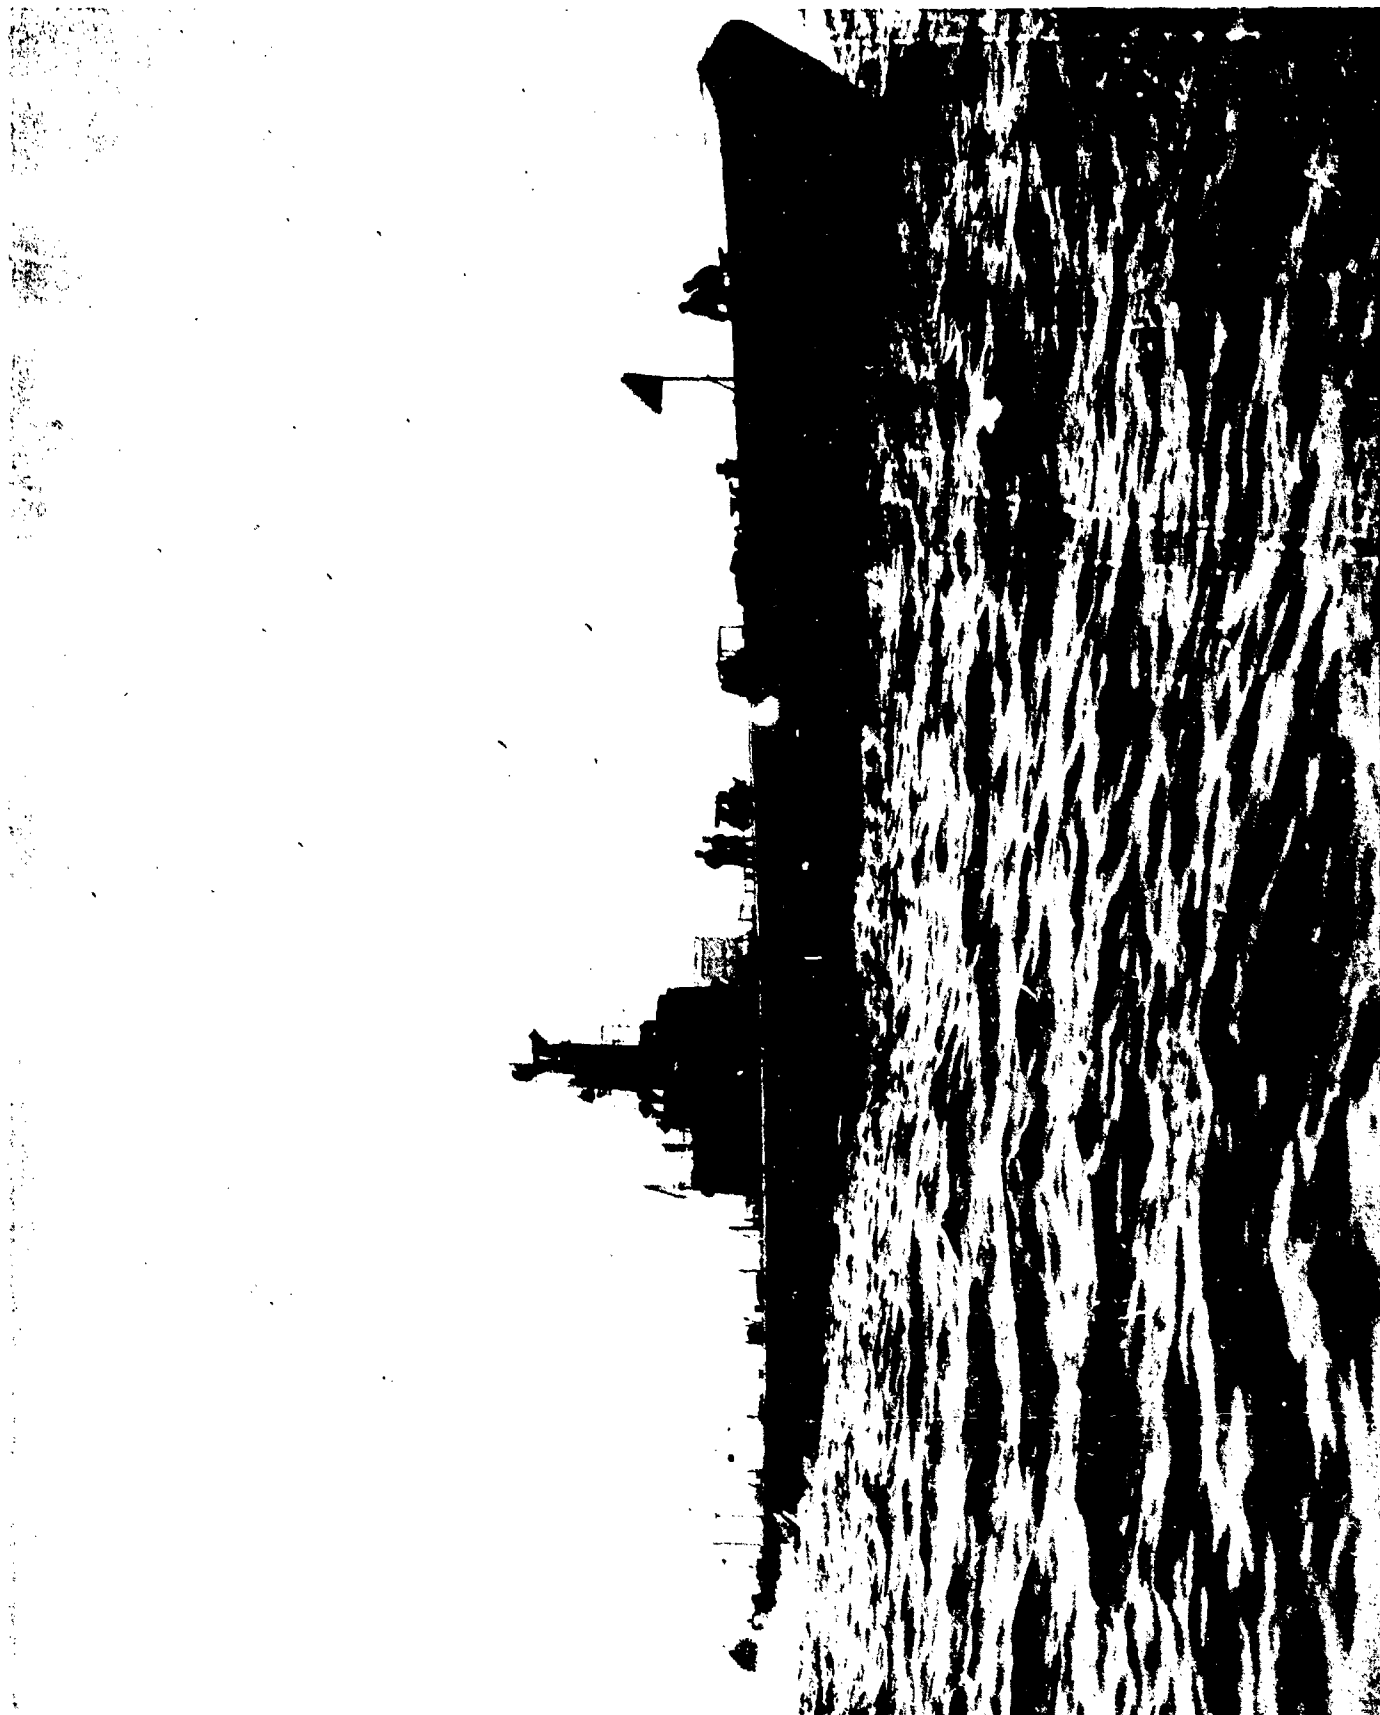
AA-CR-227-92-96. General view from starboard bow.

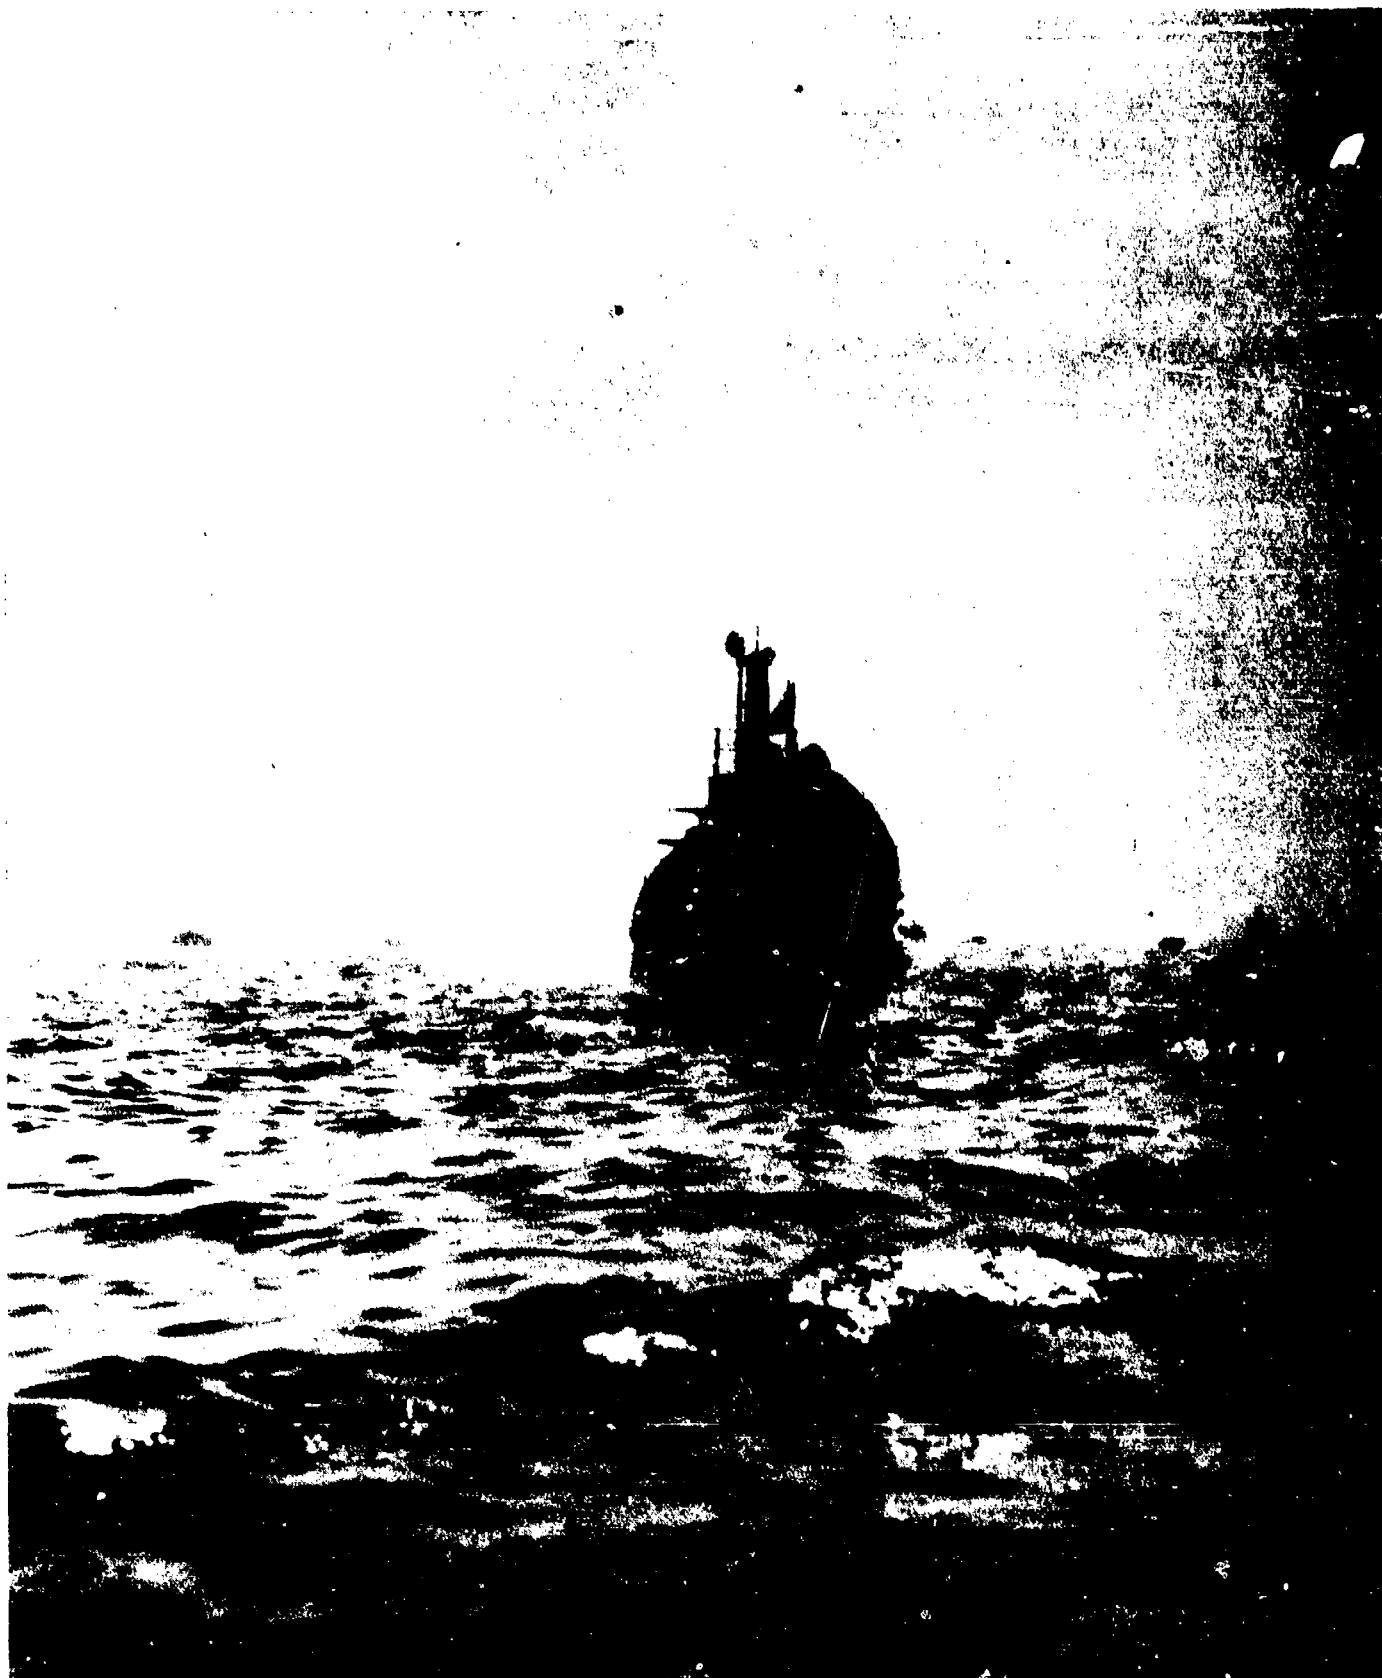
AA-CR-227-92-95. General view from ahead.

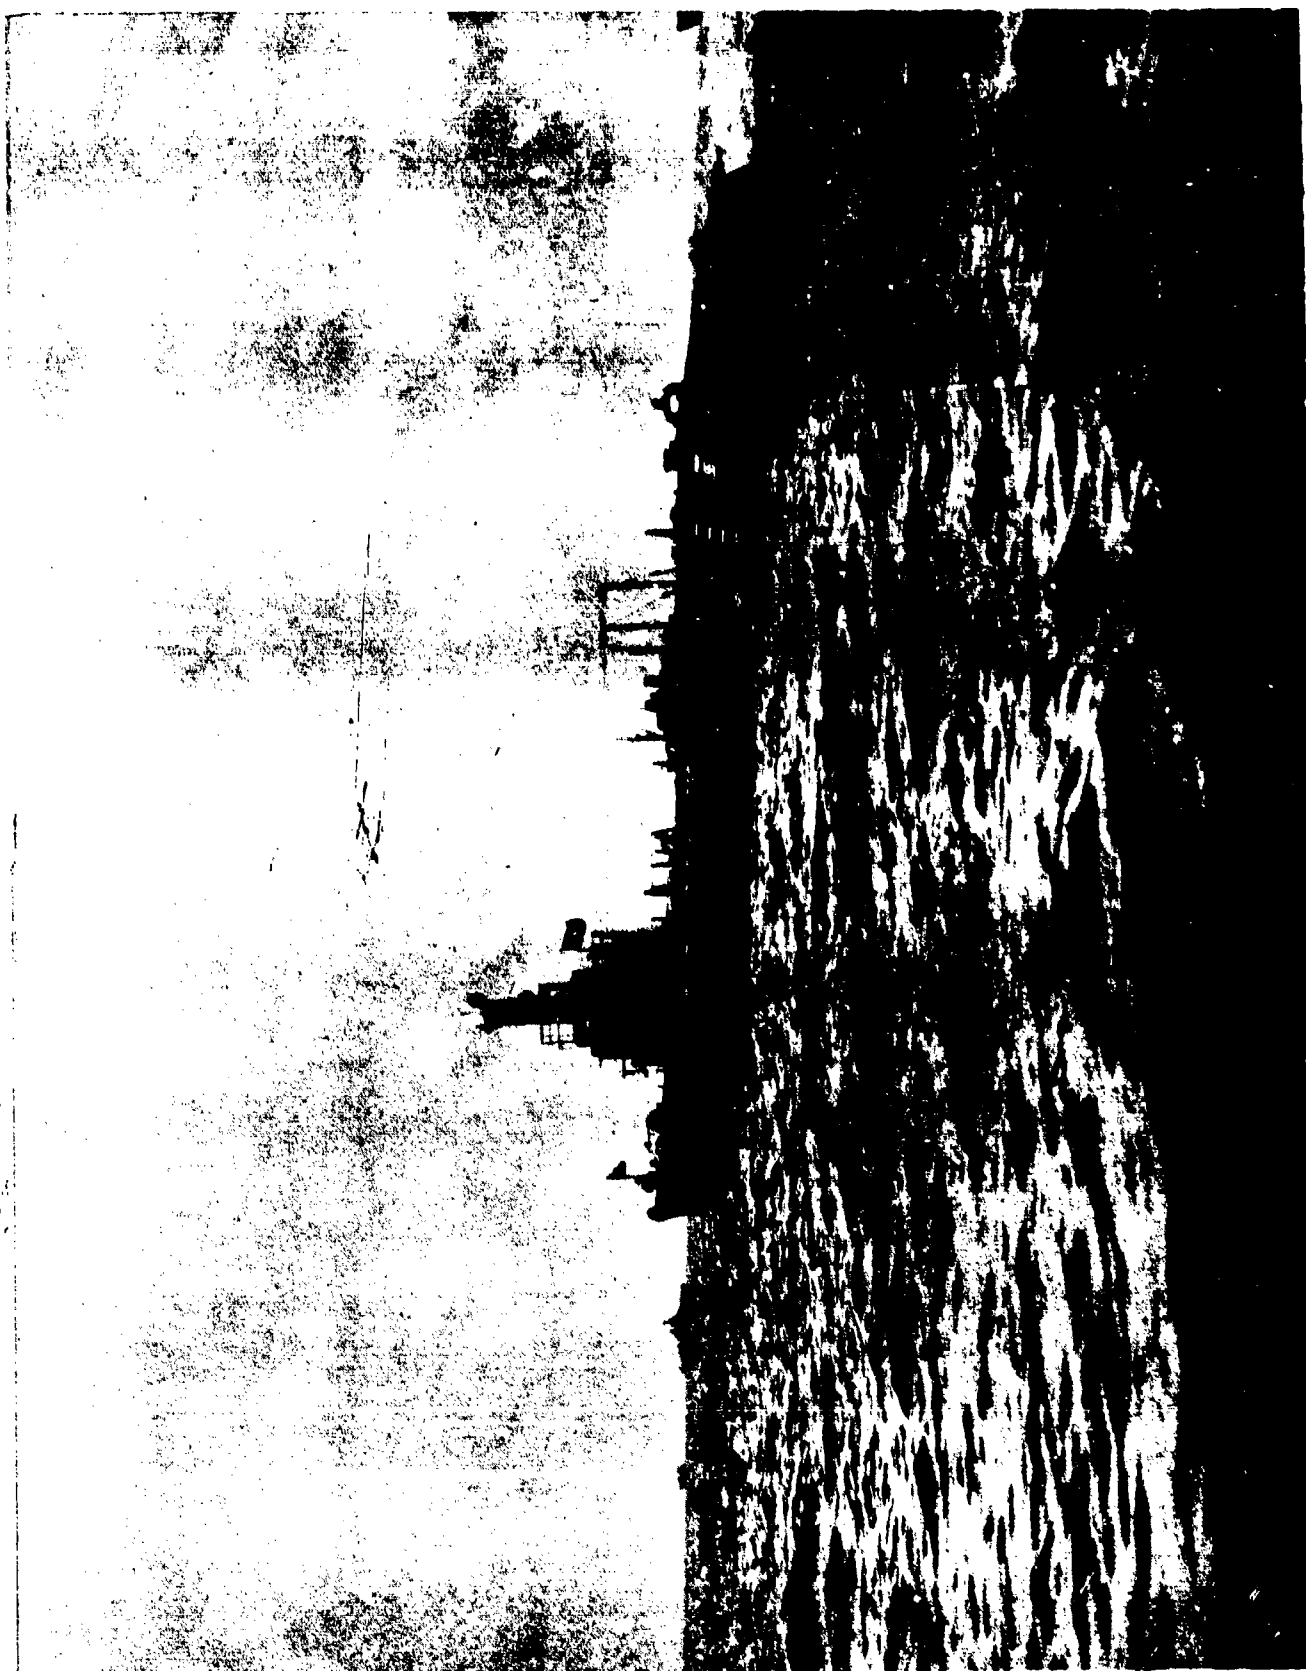
AA-CR-227-92-92. General view from port quarter.

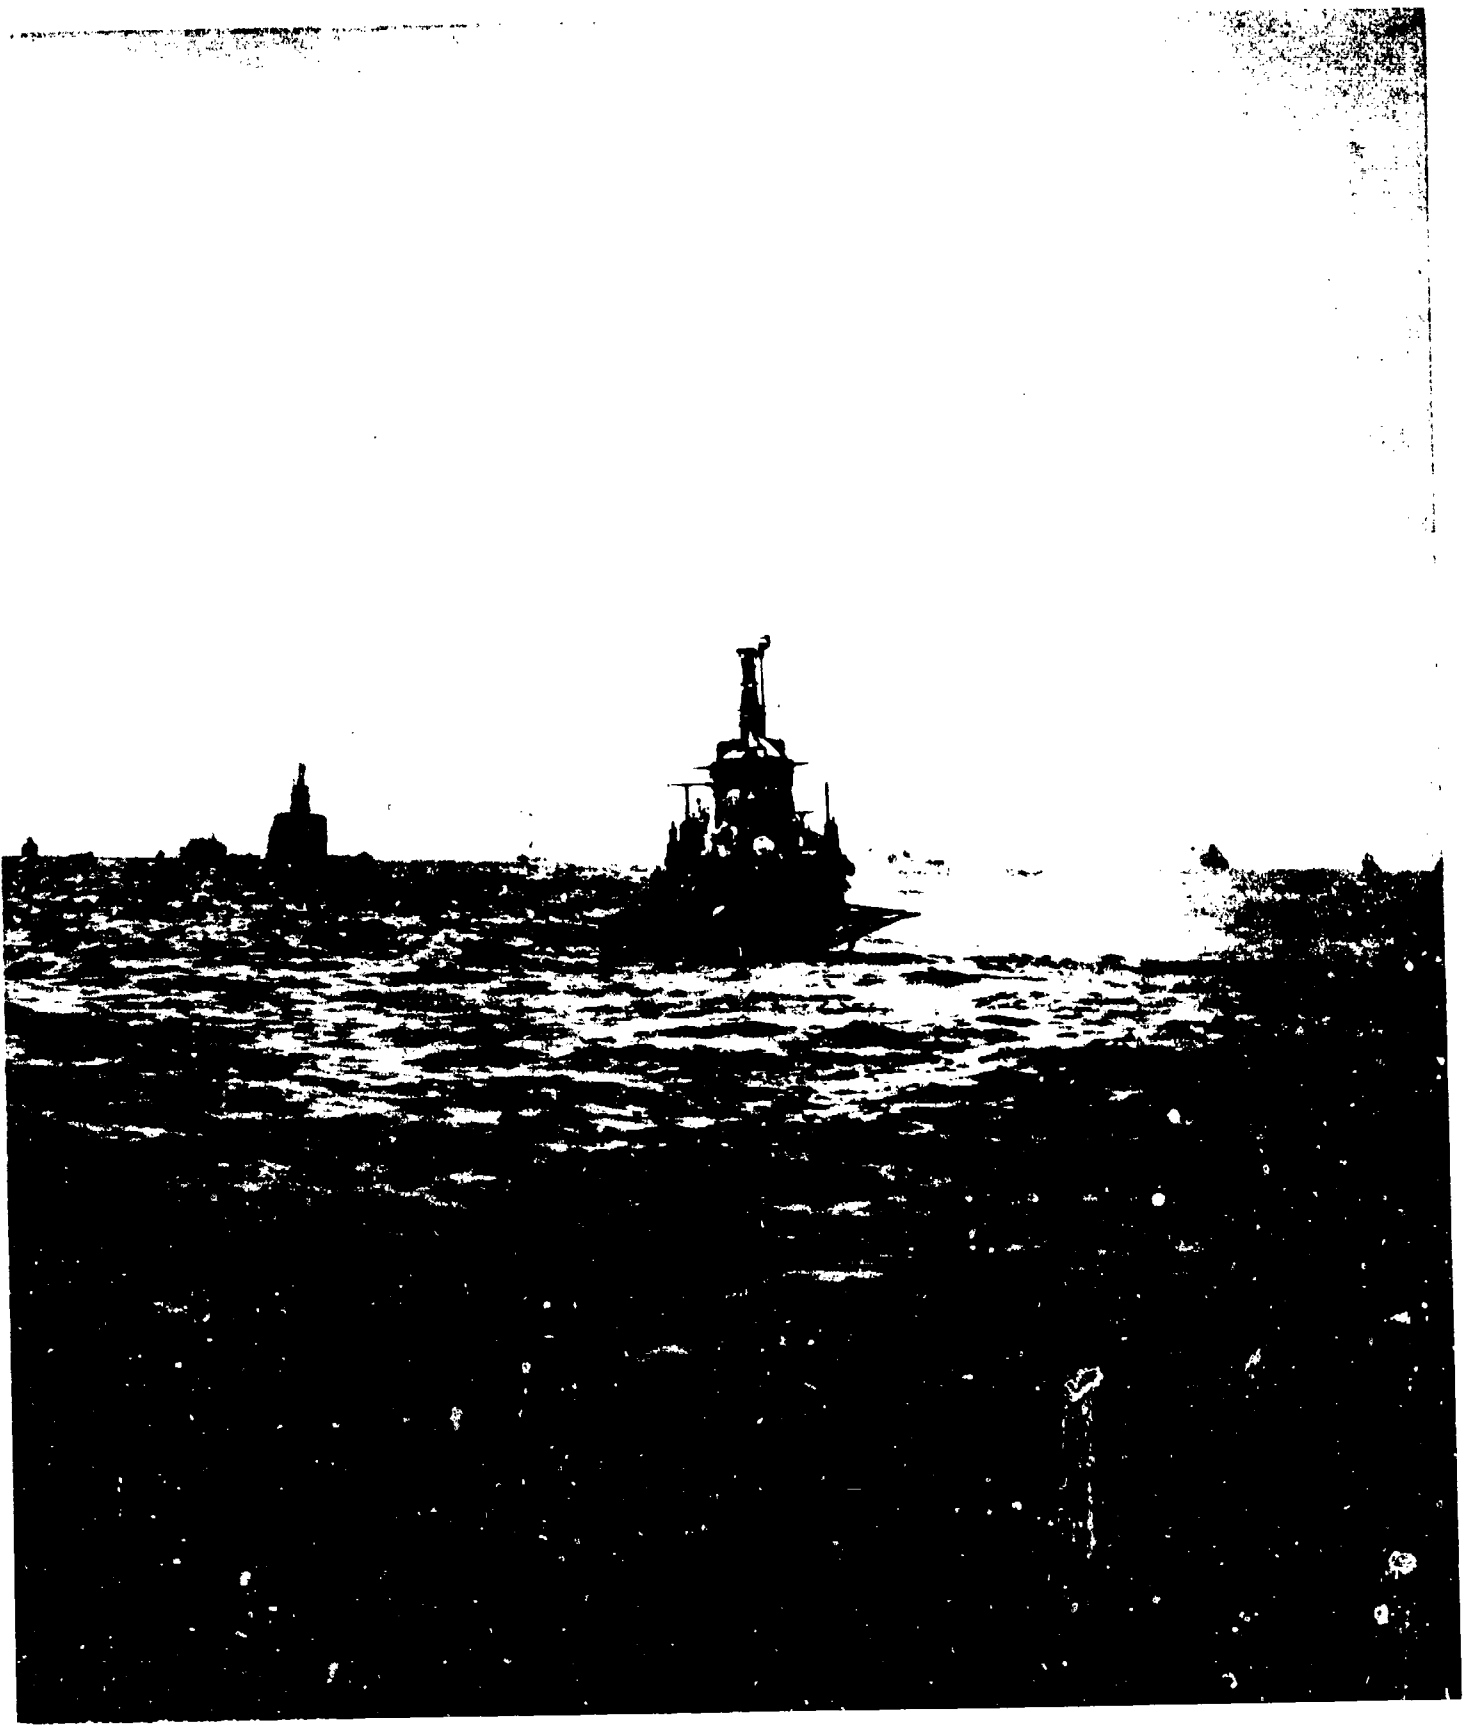
AA-CR-227-92-91. General view from astern.

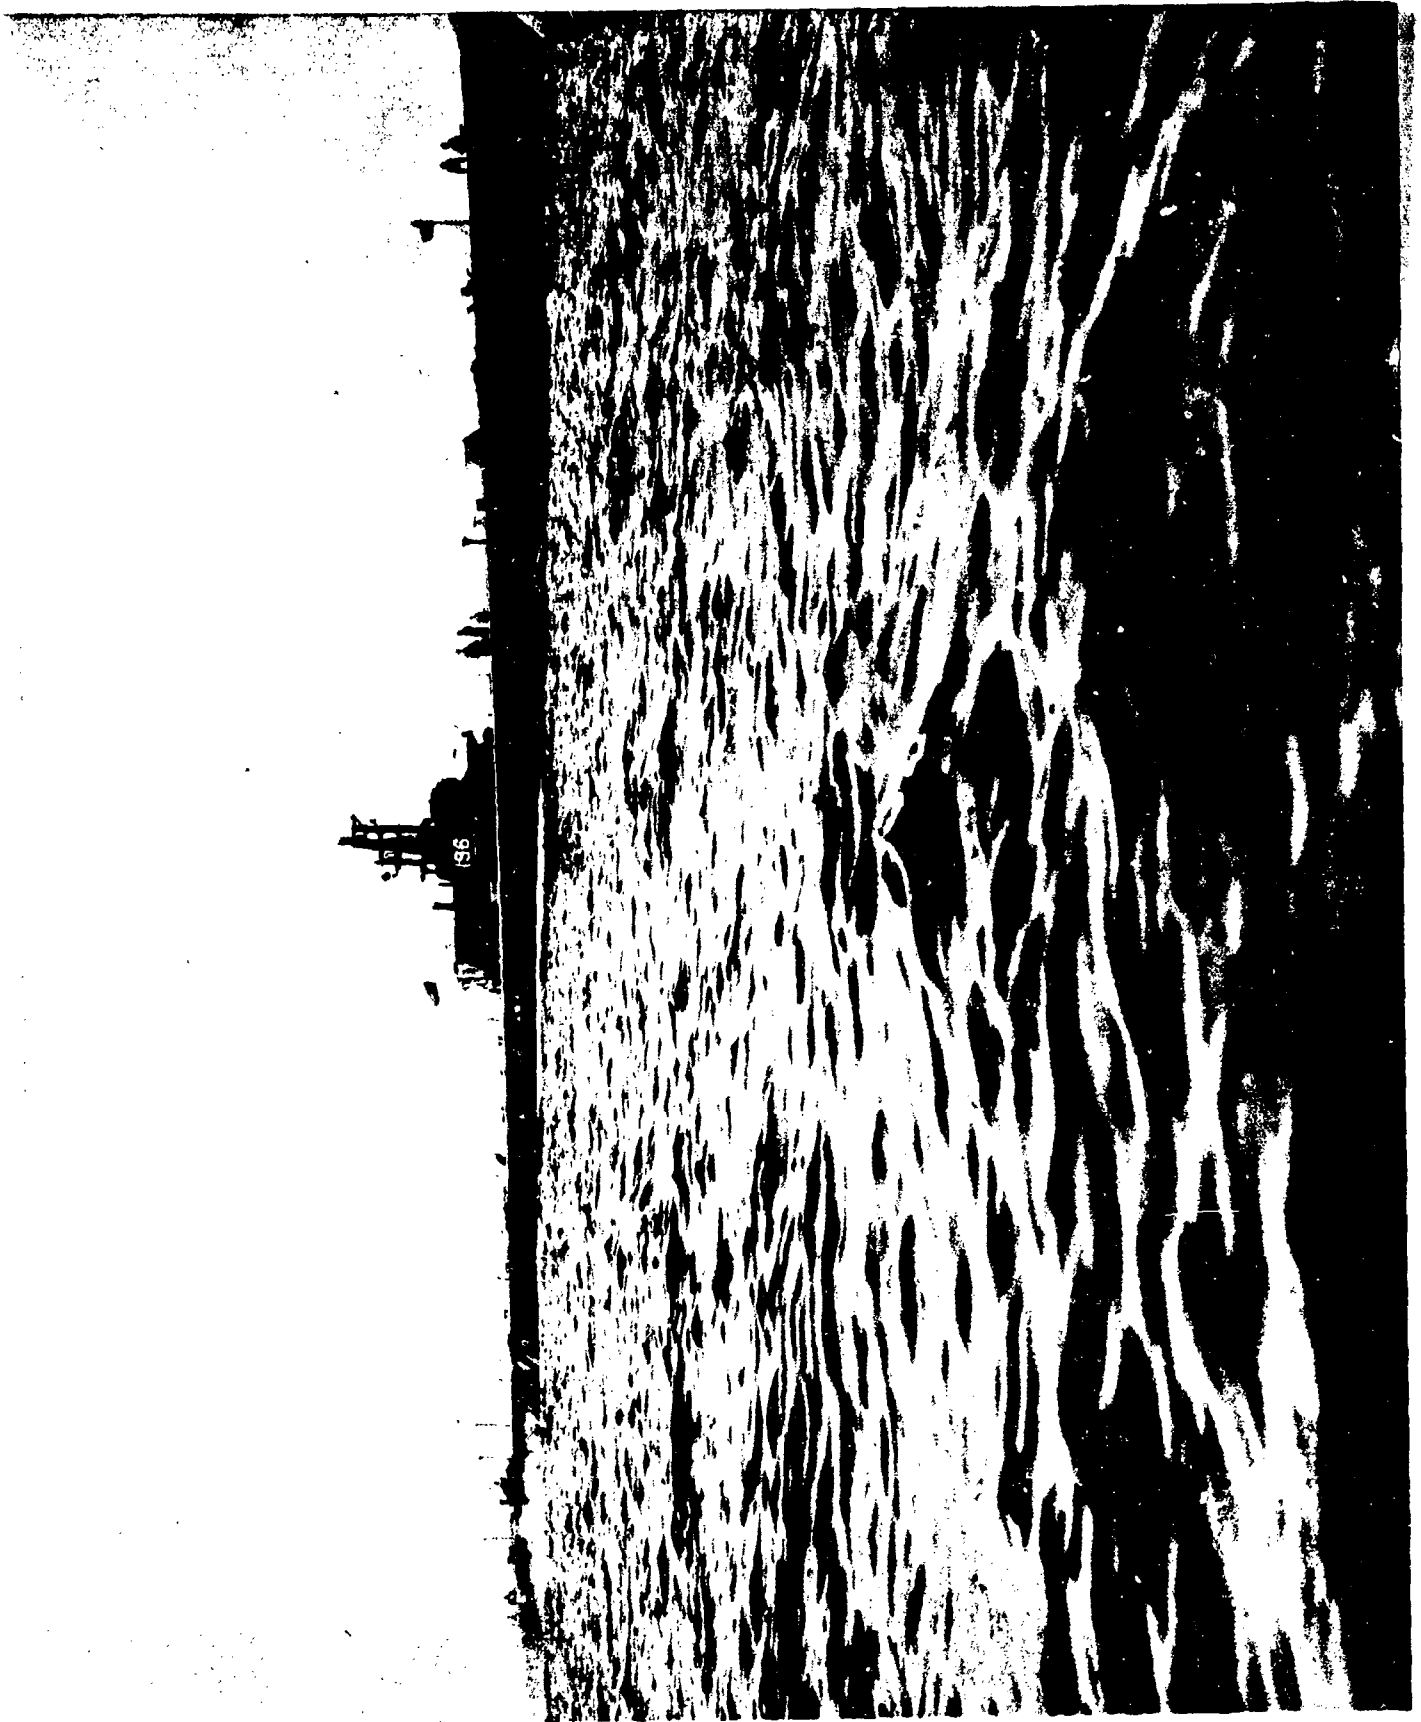
AA-CR-227-92-89. General view from starboard beam.
